Characteristics of Liquefaction-Induced Damage in the 2011 Great East Japan Earthquake

K. Ishihara

ABSTRACT: Features of the 2011 earthquake in Japan are characterized by predominance of the ground failure due to liquefaction and scour of the ground caused by Tsunami. Unprecedented long duration of the shaking and extensive occurrence of liquefaction in Tokyo Bay area 300~400km distant from the epicentral area are also the characteristic features of the earthquake. Many specially designed tsunami seawalls were destroyed by the raid of the giant tsunami as high as 15~20m in the coastal region of the northern part of Japan mainland. The results of preliminary investigations and simple analysis on the liquefaction-induced damage are introduced herein, together with lessons learned from the destruction.

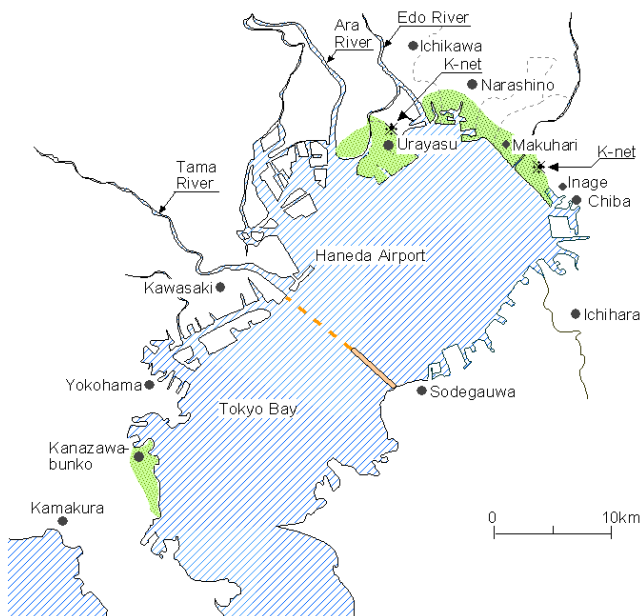
Figure 13 Liquefaction-affected areas in the Tokyo Bay

The areas of liquefaction are roughly displayed in Figure 13 where it is noted that its effects extended south to the city of Kanazawa-bunko and also that the low-land areas west of the lower reach of the Edo River in Tokyo suffered the damage due to liquefaction. Several cities in Chiba Prefecture east of Urayasu were affected more seriously by the liquefaction. These cities are shown in Figure 14.

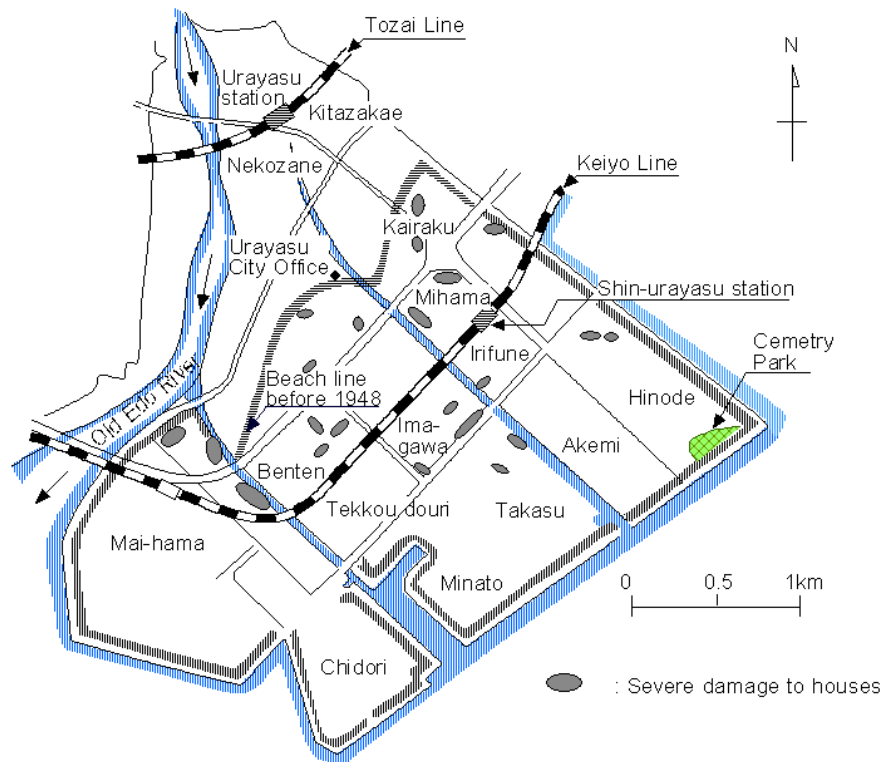
Figure 15 Places of the serious damage to private houses in Urayasu

Amongst the cities in Chiba Prefecture, Urayasu was the one most seriously damaged by liquefaction. The major towns in Urayasu are indicated in Figure 15 where apparent signs of liquefaction were observed at the time of the first strongest shaking on March 11, 2011. Most of the areas affected were those reclaimed over the period of 1960~1980 and developed to provide landspace for residential houses, parks, schools and warehouses for industries. There was a sharp contrast between the areas of liquefaction or no liquefaction which are divided by the old shore-line before the reclamation started each in 1960's. This boundary line is indicated on the map in Figure 15.

Figure 15 where it is noticed that the area north of the old beach line as of 1945 remained intact, not affected by liquefaction, in spite of the lower elevation of the ground surface as compared to that in the near-shore reclaimed area. The soil profile at Urayasu consist generally of loose sand layers of reclaimed and alluvial

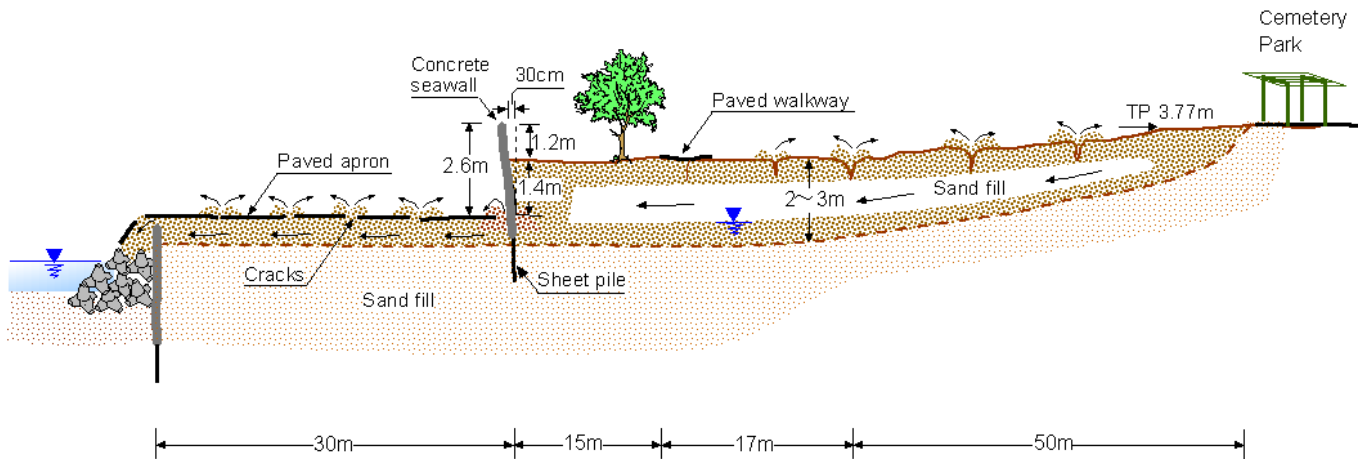
Figure 25 A conceptual picture of the lateral spreading at the seaside zone in the south of the Cemetery Park, Urayasu

The concrete seawall in the landside was also seen having deformed seawards by 20~50m as indicated in Figure 25, which is indicative of the mass of liquefied sand deposit having slid along the likely sliding plane as indicated by a dashed line in figure.

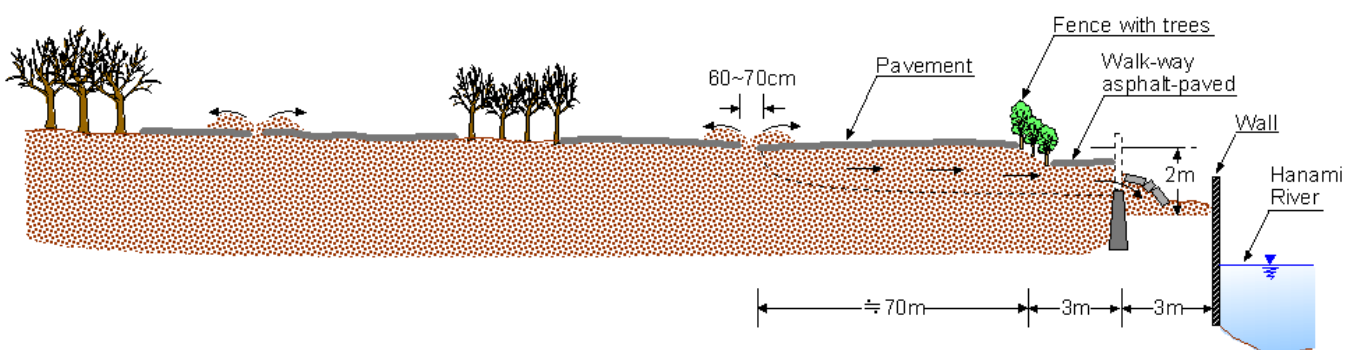
Figure 33 A conceptual sketch across the Traffic Park for the lateral flow of the liquefied sand towards the Hanami River

The Traffic Park is bordered by the line of bush fence on the walkway about 1.0m lower in elevation which is located along the Hanami River immediately on the south. The concrete wall along the river was turned down as viewed in the photo of Figure 32(a). There was a considerable amount of sand that had spread over the apron one step down the walkway as shown in Figure 32(b). It is highly likely that the liquefied sand over the park premise about 2m higher in elevation had flowed underground towards the Hanami River and pushed out the walkway wall, resulting in the collapse of the wall and spreading of the sand over the apron. The scenario as such is displayed in the cross sectional sketch shown in Figure 33.

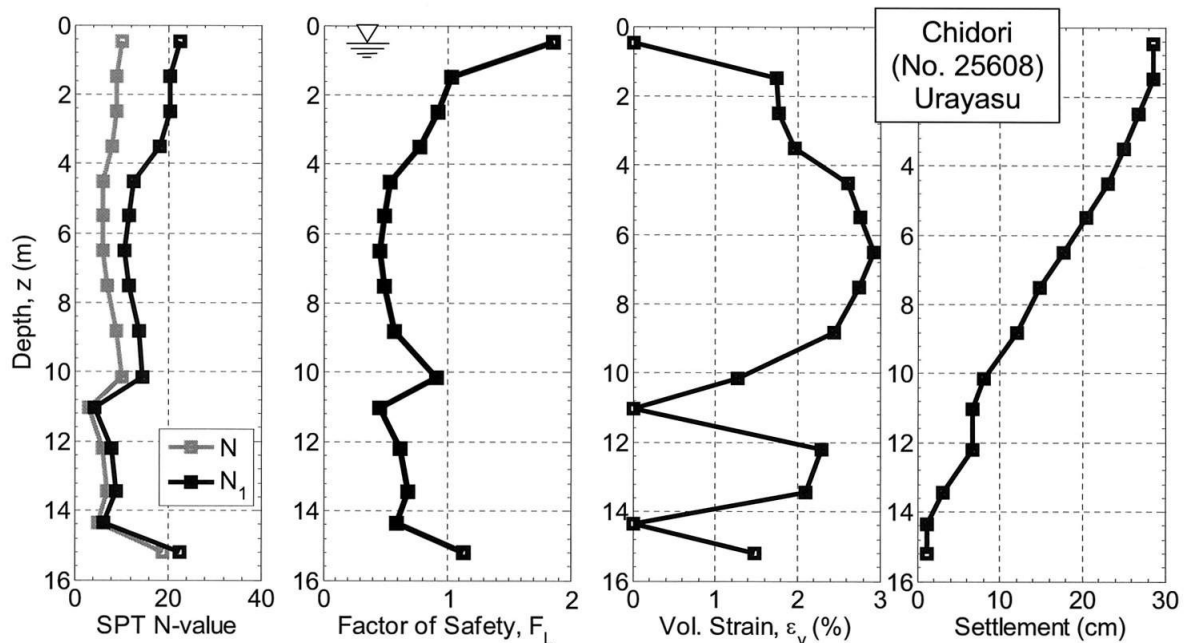
Figure 37 Analysis of liquefaction for a site at Chidori, Urayasu

A site at Chidori was chosen as a place for liquefaction. The soil profile and its location are shown in Figure 36. The results of the liquefaction analysis are shown in Figure 37. The analysis was made for the near-surface sandy deposits to a depth of 15m. This is the site where signs of liquefaction were

visible at the time of the earthquake. The factor of safety against liquefaction is shown in Figure 37 to be less than unity generating the volume strain of $\varepsilon_v = 1-3\%$ through the depth of 2 to 11m. The settlement of the ground surface was obtained by integrating the volumetric strain at each depth, coming up with a value of 30cm.

The actual settlement exactly at this place was estimated to be 50~70cm judging from the post-quake ground elevation relative to a nearby factory building

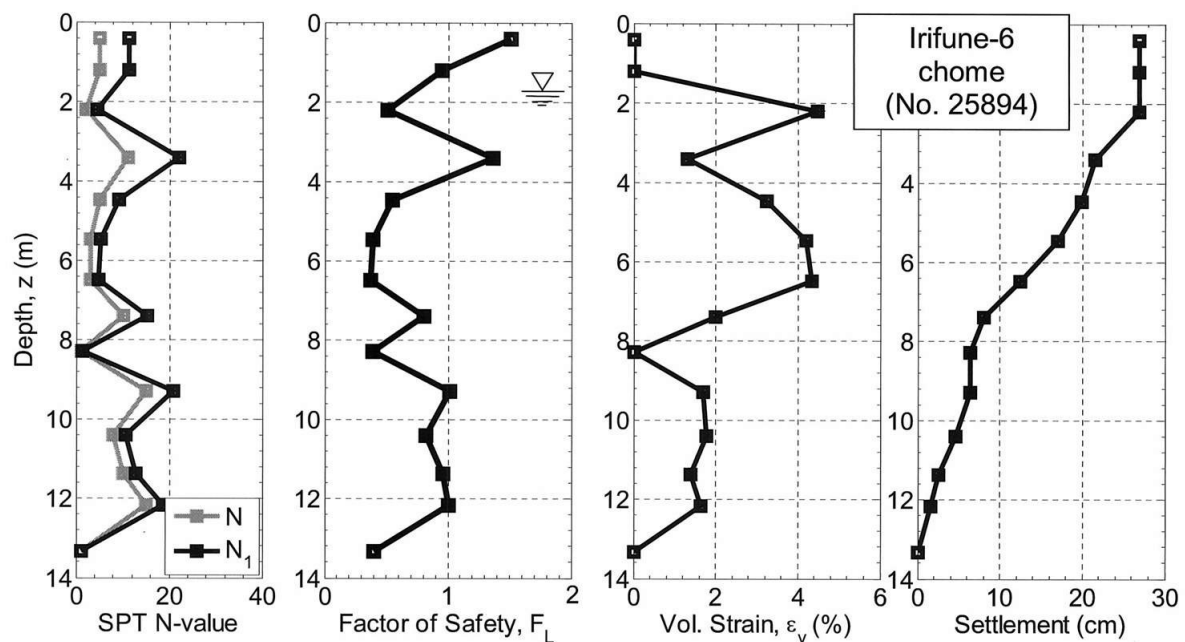
Figure 39 Analysis of liquefaction for a site at Irifune 6-chome, Urayasu

Another example of comparison between the estimated and observed value was made for the site of Irifune 6-chome of which the soil profile is shown in Figure 38 together with the location in the inset. Results of analysis are shown in Figure 39. The actual settlement was inferred to be 30cm by comparing the post-earthquake ground level to the trace of the pre-earthquake ground surface marked on a pile-supported column of a nearby overpass walkway. As shown in Figure 39 the estimated settlement was 29cm indicating good coincidence with the actual value.

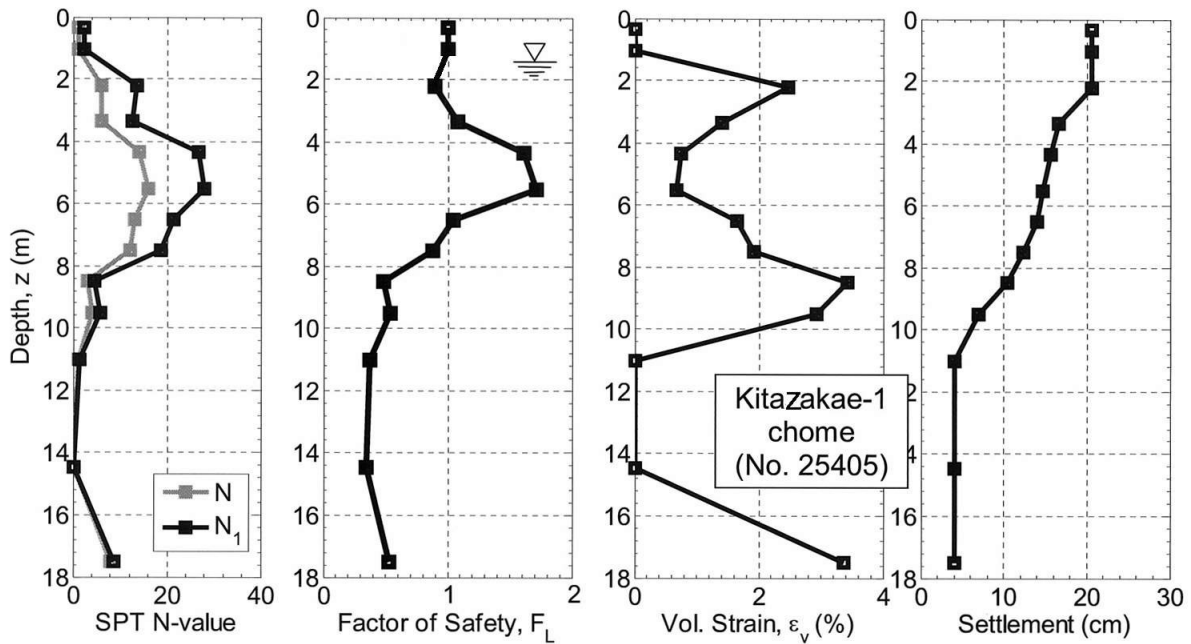
Figure 43 Analysis of liquefaction for a site at Kitazakae 1-chome, Urayasu

The results of liquefaction analyses are shown in Figure 41 where the settlement is calculated to be 16cm. This value is also plotted in Figure 43. Similarly analysis was performed for another site of no-liquefaction, viz., at Kitazakae 1-chome, where the soil profile consists of relatively dense sand of alluvial origin as indicated in Figure 42. The calculated settlement is shown in Figure 43 being of the order of 10~20cm.

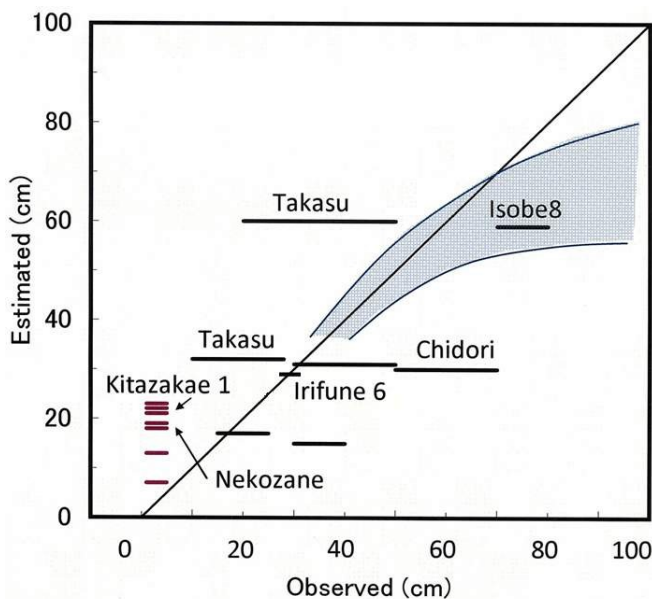
Figure 44 Comparison of estimated and observed settlements in Urayasu

There are several other sites in the city of Urayasu for which estimate was made by using the simple method as described above. All the data obtained from calculation are plotted in Figure 44 versus actually observed values. As there are several sites where actual values of settlements are difficult to determine uniquely, they are demonstrated in the form of ranges

of variation in Figure 44. Looking over the plots in Figure 44, one can recognize main points as follows.

(i) For the sites with no evident sign of liquefaction, the computed values of settlement are larger than those observed actually after the earthquake. There might have been some settlements which was not discernable, but the SPT N-values in the soil profile used for assessment of the volumetric strain may not reasonably reflect the ground conditions particularly consisting of alluvial sandy deposits where cementation or aging effects are predominant.

(ii) For the sites with apparent sign of liquefaction, the estimated settlements show values of 20~30cm which is coincident, by and large, with the actual values observed at the time of the earthquake.

(iii) In the range of larger settlements roughly in excess of 40cm, the observed settlements appear to show values which are greater than those estimated by calculation as indicated by shaded zone in Figure 44. Most likely, this is due to loss of the large amount of liquefied sand which ejected on the ground surface. In the current methodology, it would be difficult to take into account the amount of sands which ejects out of the ground when liquefaction occurs.
